Calorifier Vessel Repair

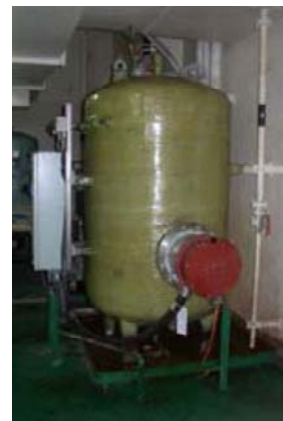
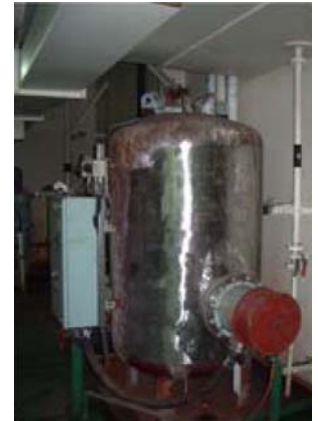
As part of the commissioning process of an FPSO, built and commissioned in Korea, fresh water medium was utilised for the pressure systems. This water contained Microbial content (suphate reducing bacteria (SRBs)). After a 3 ½ year period, SRBs resulted in the break down of the vessel's parent substrate producing internal pitting, weld cracking and subsequent shutdown of the calorifier.

The vessel specification was a design pressure of 8 Bar, design temperature of 85°C and vessel substrate comprising of 304 grade stainless steel. Due to the ambient environment the repair would be installed within, the Technowrap 2K H.A™ (High Ambient) system was used for successful repair installation restoring the vessel to its full integrity and to its original design specification.

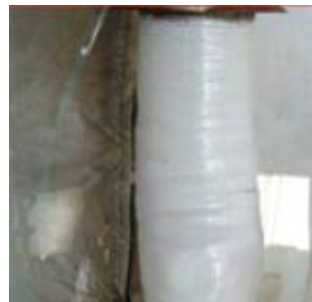
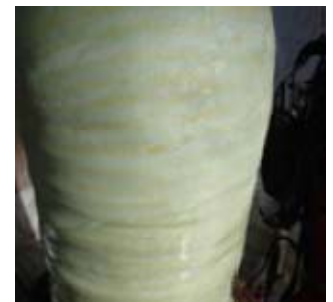
A closed drain system section within the splashzone area was identified as having suffered circumferential weld cracking, internal erosion and local wall thinning leading to a pinhole through-wall-defect. A temporary bandage repair had also been applied.

A Technowrap 2K™ repair would be installed repairing the defected area providing a design lifetime extension of 3 years. This 2K™ repair was also suitable for the assets design pressure of 11.34 Bar and design temperature of 38°C.

Using a custom built platform and habitat gave a degree of protection from the weather and from any stray waves rising higher than the platform floor. Rope access trained personnel applied the repair at height from a suspended platform at the required location.

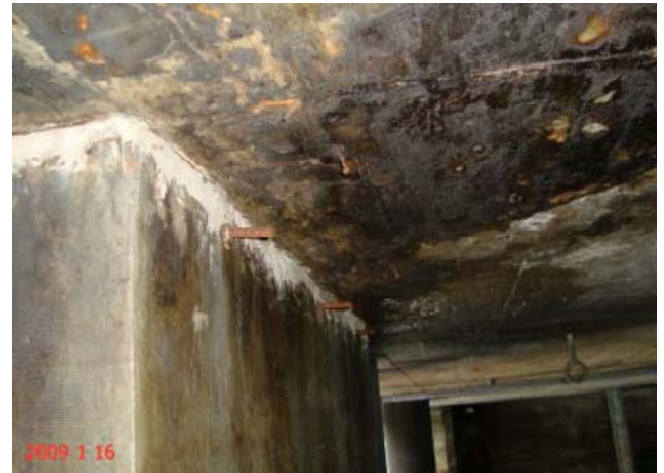
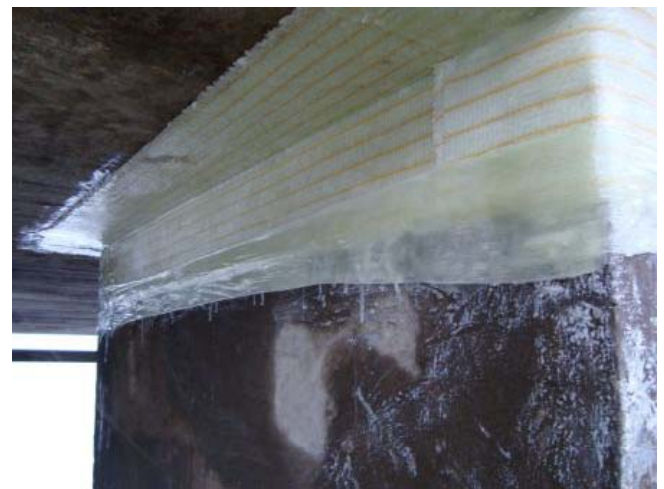
A square concrete sump located underneath a concrete jetty had sustained cracks at the top connection between the sump and the sea jetty. During operation the liquid level of the sump would rise to the top of the sump and the contents, an oil and water mixture, would seep through these cracks. The leakage of this oil/water liquid into the sea created an environmental issue requiring a long term repair solution.

It was not possible to replace the damaged sump and previous alternative repair methods attempted were unsuccessful. From a design engineered perspective, Technowrap 2K™ was ideal in repairing the sump whilst also providing the sump with an extended design life of 20 years.

Pre-fabricated sections of the repair were manufactured at Walker Technical and shipped to the jetty location ensuring curing could take place prior to the incoming tide.

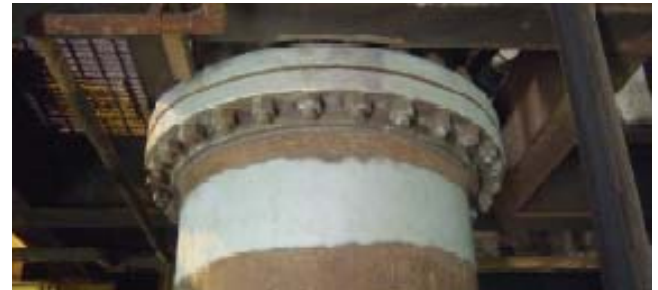
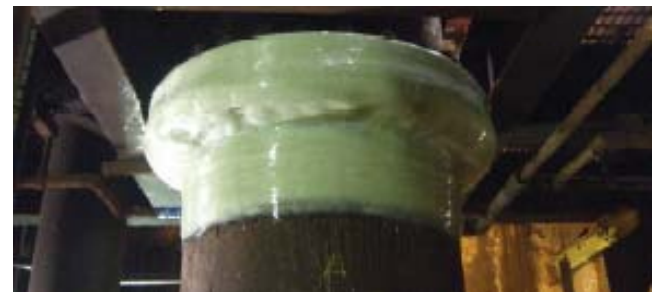
A weld on a cooling water return line had an internal corrosion defect, taking it close to the minimum allowable wall thickness.

Applying a composite repair would resolve many of these challenges associated with line replacement. Following results of line calculations carried out, a composite design engineered repair was applied extending the lifetime of the line for a further 2 years.

The repair was designed for a reduced landing of 110mm, compared to the original of 160mm as stipulated in the original design. This allowed for the repair to finish on the edge of the flange while still maintaining the integrity of the line.

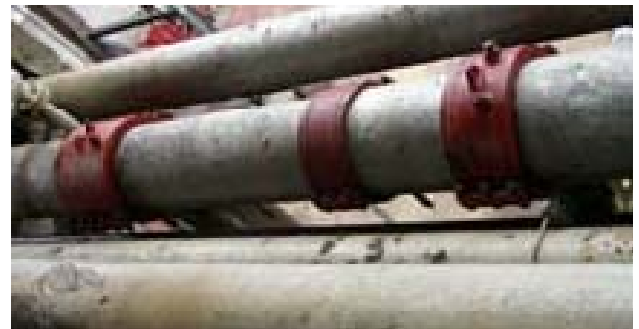
A high temperature flare line was suffering from a combination of external corrosion and internal erosion. The pipework contents also included high levels of H²S implying difficulty in maintaining safe access with potential of sour gas egress.

As per design calculations a repair was installed using Technowrap 2K H.T™, a high temperature system capable of installing a repair to this particular lines design operating temperature of 204°C. A post cure method was used with Barcol hardness checks to ensure the repair systems full cure.

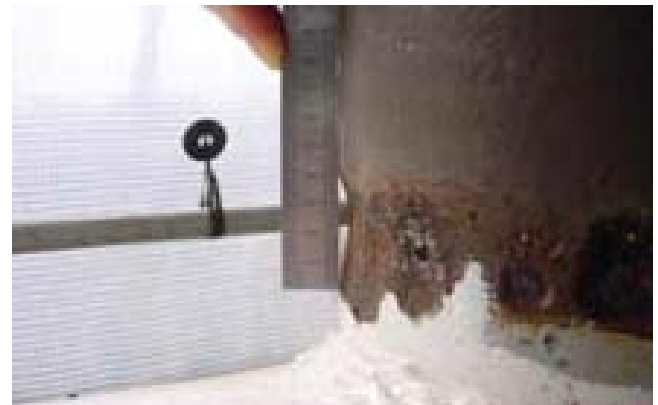
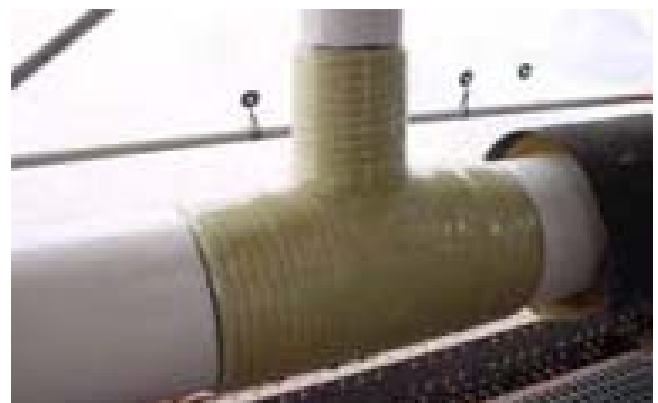
A major Metering Skid Line, with 17 platforms feeding into the system, was found to have Corrosion Under Insulation (CUI), and the Remaining Wall Thickness (RWT) was below 50% of the maximum allowable working pressure.

The line was a 16 x 8" branch section. Due to Stress loadings (axial loads and bending moments), stress analysis was required in the XYZ axis of the 8" branch. A design analysis was completed with recommendation to install the Technowrap 2K™ system whilst the line was 'live'.

A Walker Technical technician mobilised at short notice to begin the installation process and to provide total encapsulation of the line using the Techowrap 2K™ system. This design engineered repair extended the life time of this crucial line by a further 20 years. Post cure and barcol hardness checks were undertaken to ensure complete cure was achieved.

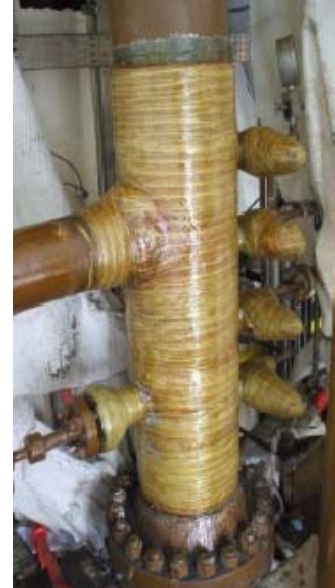
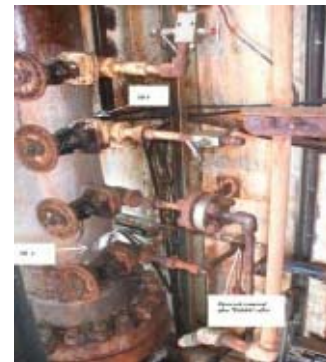
Various valves and branches from a crude oil export line were suffering internal corrosion and wall thinning, resulting in the pipe having as little as 2mm of a wall thickness.

Through adaptation of the standard resin used within the Technowrap 2K™ system, a high temperature (H.T.) repair was installed successfully providing the line with an extended design life of 2 years until fabrication of the new line replacement would be complete, allowing change out the existing pipe work.

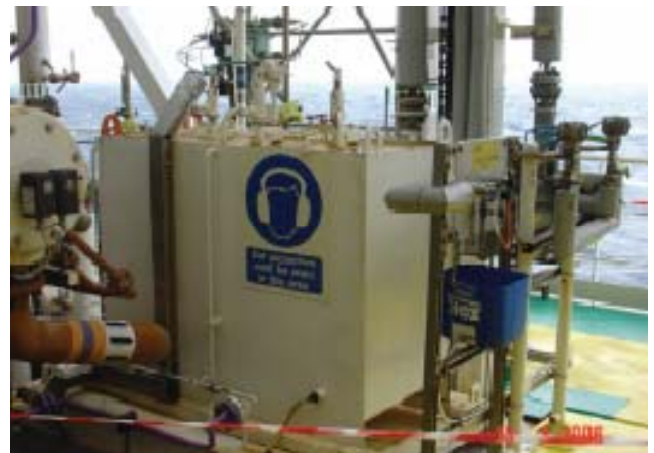
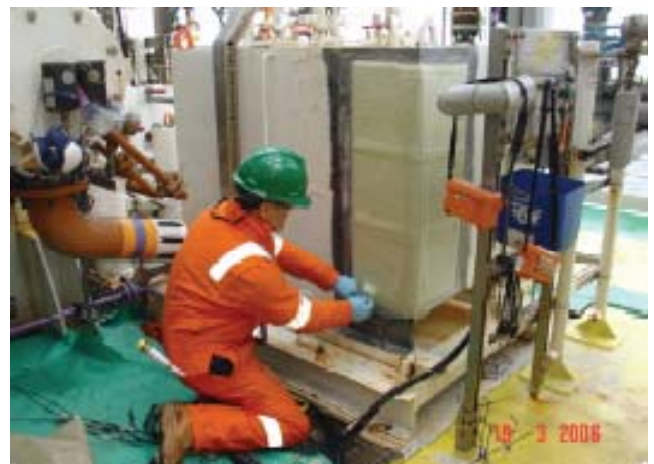
A glycol tank (part of the water injection pump skid) suffered a 4mm single fillet weld rupture due to high vibration levels on the skid. A repair was required.

Within this specific maintenance task it was evident the standard installation technique may fail to reach full compression prior to the curing stage. To remedy this, a new approach was taken in installing the standard Techowrap 2K™ system whilst vacuum bagging procedures were used to ensure full compression achievement prior cure.

Following repair installation with implementation of vacuum bagging techniques, the tank still had ongoing vibration. However it was still in service 12 months following the repair installation. At this time an opportune shut down period had still not yet occurred for the original planned tank change out.
