Calorifier Vessel Repair

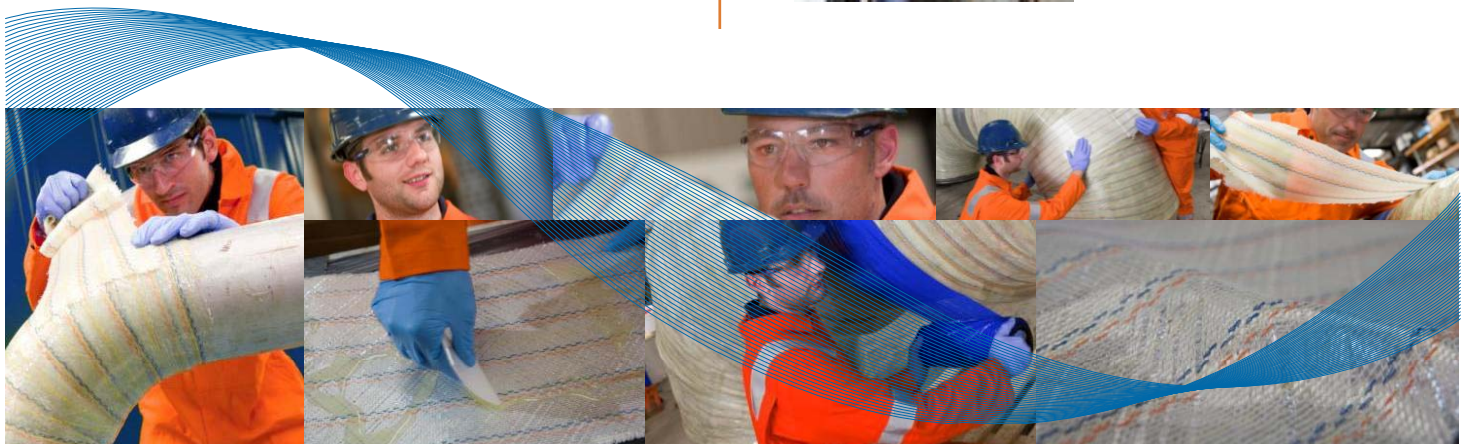
High Temperature Flare Line Repair

A high temperature flare line was suffering from a combination of external corrosion and internal erosion. The pipework contents also included high levels of H²S implying difficulty in maintaining safe access with potential of sour gas egress.

As per design calculations a repair was installed using Technowrap 2K H.T™, a high temperature system capable of installing a repair to this particular lines design operating temperature of 204°C. A post cure method was used with Barcol hardness checks to ensure the repair systems full cure.
